## Hydrogen assisted crack initiation and propagation in a nickel-based superalloy

To understand the mechanism for hydrogen-induced embrittlement in a nickel-based superalloy, detailed electron microscopy characterisation has been employed on the UNS N07718 (Alloy 718) after hydrogen charging and slow strain rate testing to investigate the strain localisation and damage accumulation caused by hydrogen. Transmission Electron Microscopy analysis demonstrates that the microstructure of the material after tension is characterised by planar dislocation slip bands (DSBs) along {111} $\gamma$  planes. Consistent results from Electron Channeling Contrast Imaging (ECCI) reveal that cracks always propagate along planar DSBs in the presence of hydrogen. This phenomenon is rationalized by the evident nucleation of nanoscale voids along the DSBs, especially at the intersections between nonparallel DSBs. The proposed mechanism, confirmed by both the ECCI analysis and fractographic study by Scanning Electron Microscopy, indicates that the interaction between the hydrogen and dislocations along the DSBs leads to void nucleation. Furthermore, the results suggest that coalescence and widening of vo

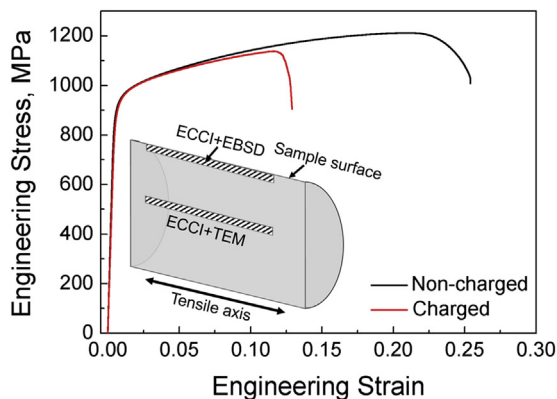
**Fig. 2.** Engineering tensile stress-strain curves for the Alloy 718 with (red curve) and without (black curve) hydrogen pre-charging. An inset schematic diagram shows the regions, with regard to the longitudinal section of the sample, where post-mortem analysis was carried out. (For interpretation of the references to colour in this figure legend, the reader is referred to the web version of this article.)

The stress-strain curves of the material, following the SSR tests with and without hydrogen charging, are shown in Fig. 2. It is found that the applied hydrogen charging has no appreciable effect on the yield stress, however, the total elongation decreases dramatically from 25% to about 12%. It is also worth noting that the work hardening rate of the hydrogen charged sample is lower than that of the non-charged sample. Fig. 2 includes a schematic illustrating the regions that were characterised in detail following the SSR experiment. Fig. 3 shows the fractographs obtained by SEM and the analysis demonstrates a multimode failure: brittle fracture features close to the sample surface ( $\sim 200 \mu\text{m}$  to the sample outer surface), typical ductile failure in the sample interior and a transitional region with mixed failure mode in-between. The brittle fracture surface is typically fairly flat, and some traces and voids can be clearly seen in the high resolution image (Fig. 3b); overall this morphology is very different from the dimple containing structure observed in the ductile failure region (Fig. 3c).

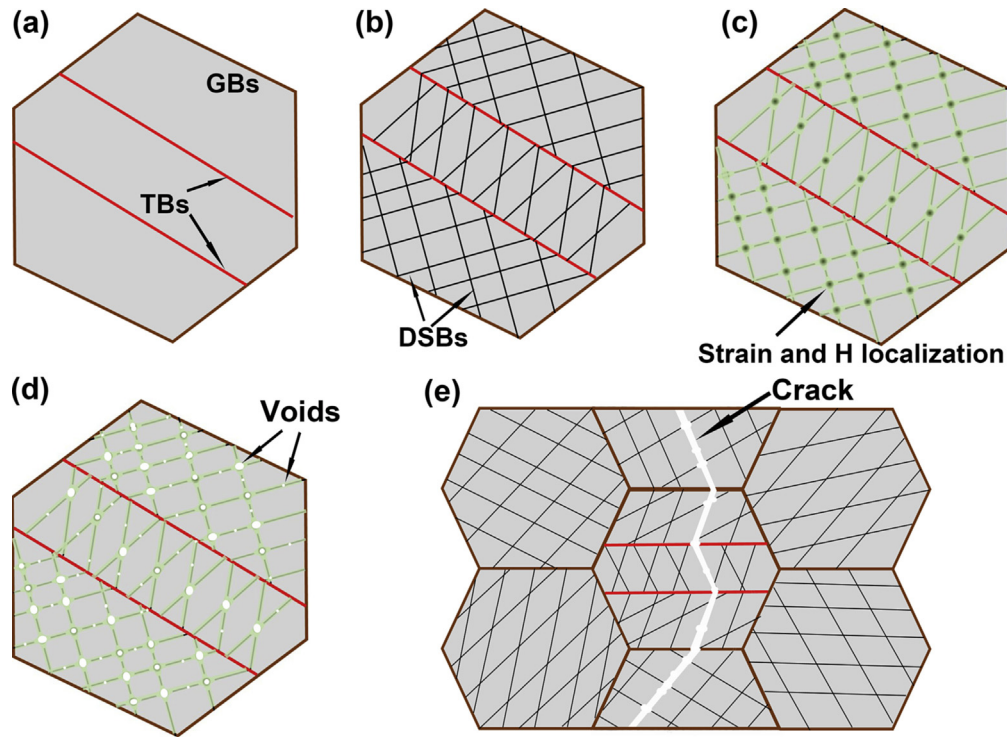
**Fig. 15.** Schematic diagrams showing the envisaged mechanism for the hydrogen induced crack initiation and propagation in Alloy 718: (a) material prior to deformation; (b) planar dislocation slip bands (DSBs) develop during tensioning; (c) on the DSBs and in particular the intersections of DSBs, slip localisation is more intensive and concentration of hydrogen is supposed to be high; (d) higher concentration hydrogen and localised slip promote the nucleation of nanoscale voids; (e) coalescence and widening of voids via dislocation process leads to crack propagation along the DSBs.

All experimental results presented here demonstrate a direct relationship between dislocation slip localisation and hydrogen assisted cracking in Alloy 718. Accordingly, an envisioned mechanism of hydrogen-induced embrittlement of Alloy 718 is proposed, which is summarized schematically in Fig. 15. Once the alloy is strained beyond yielding, dislocation generation and multiplication commence. Due to microstructural ( $\gamma'$  and  $\gamma''$ ) and alloy chemistry effects (low SFE), planar dislocation slip leads to the formation of planar dislocation slip bands, Fig. 15b. In the presence of hydrogen (here  $<200 \mu\text{m}$  beneath the surface), slip planarity and localisation is suggested to be further promoted within the framework of the HELP mechanism [18–20,46]. It has been demonstrated that dislocations are capable of transporting hydrogen at low strain rates [47,48] and dislocations can act as trapping sites for hydrogen [62]. Therefore high concentrations of hydrogen agglomerate at dislocation slip bands, especially at their intersections (Fig. 15c). Consequently, extensive hydrogen-dislocation interaction at these sites leads to the formation of nano-voids. Nano-voids weaken the dislocation boundaries and their subsequent widening and coalescence via dislocation process results in crack initiation and propagation along the dislocation boundaries (Fig. 15d). It should be mentioned that in the present study the effect of  $\gamma''$  precipitates on the hydrogen embrittlement is only in respect to the promotion of slip localisation and constrain of dislocation cross slip. The detailed microstructural analysis did not provide any evidence for decohesion along the  $\gamma/\gamma''$  interface, despite such interface potentially being the trapping site for hydrogen. Future work employing nanoscale secondary ion mass spectrometry will be carried out to
